Projects- Examines of built environment

Surveys of public institutions and community services, whether they are barrier-free and universally designed (since 2015 continuously):

Survey about 5 buildings of the Technical University of Budapest (2015).

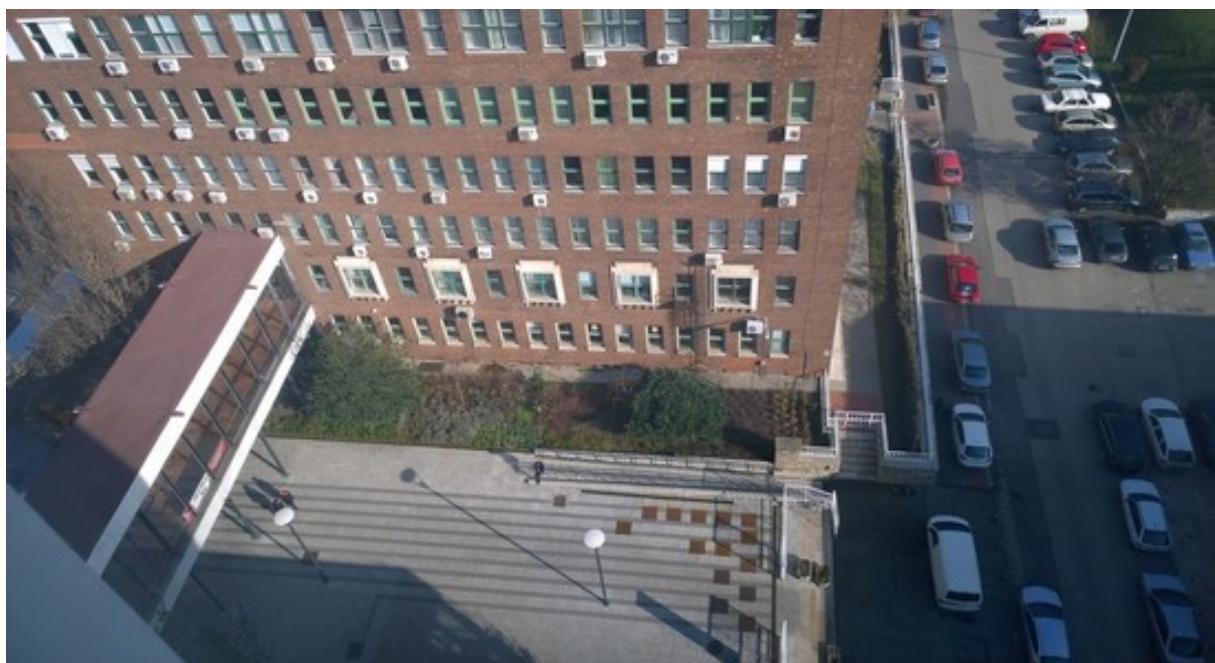
Fig 1. View from Building E of BME. You can see the connections between the sites around the buildings and the decorative-guiding lanes, 2015. Source: ETIKK

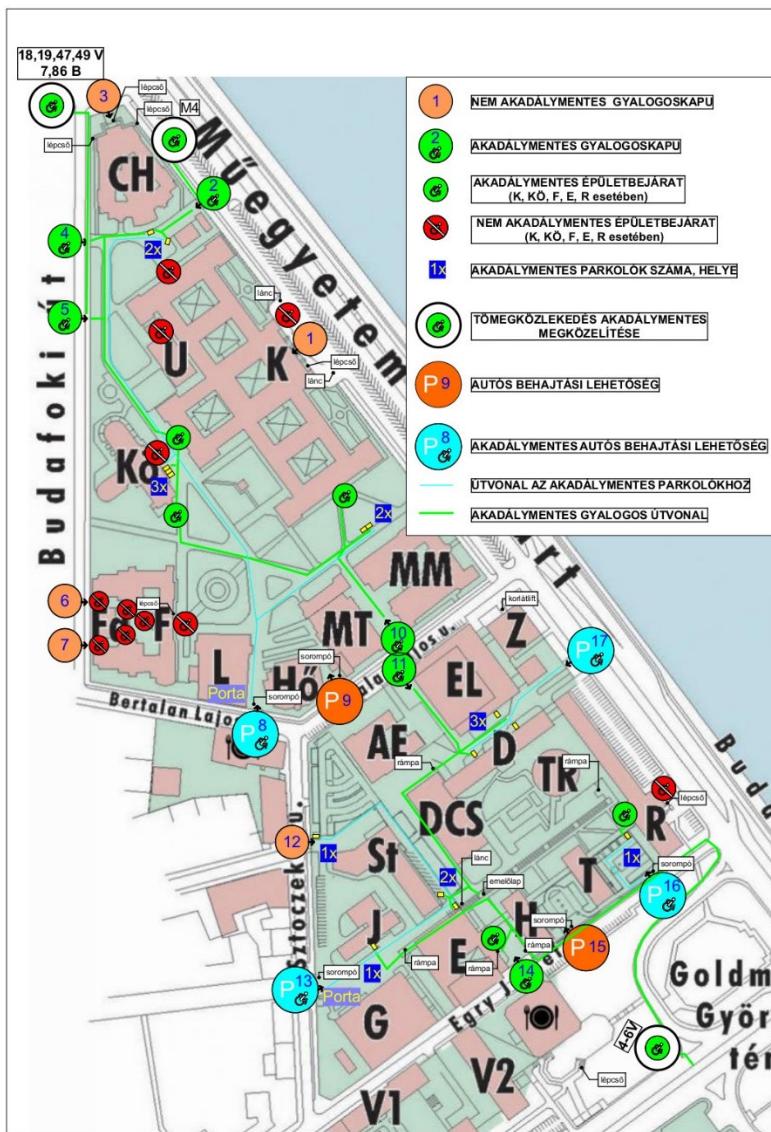
A map was created about the accessible traffic routes of the campus and the accessible entrances and parking lots of the examined buildings.

Fig 2 – traffic map of the campus's accessible connections, 2015. source: ETIKK

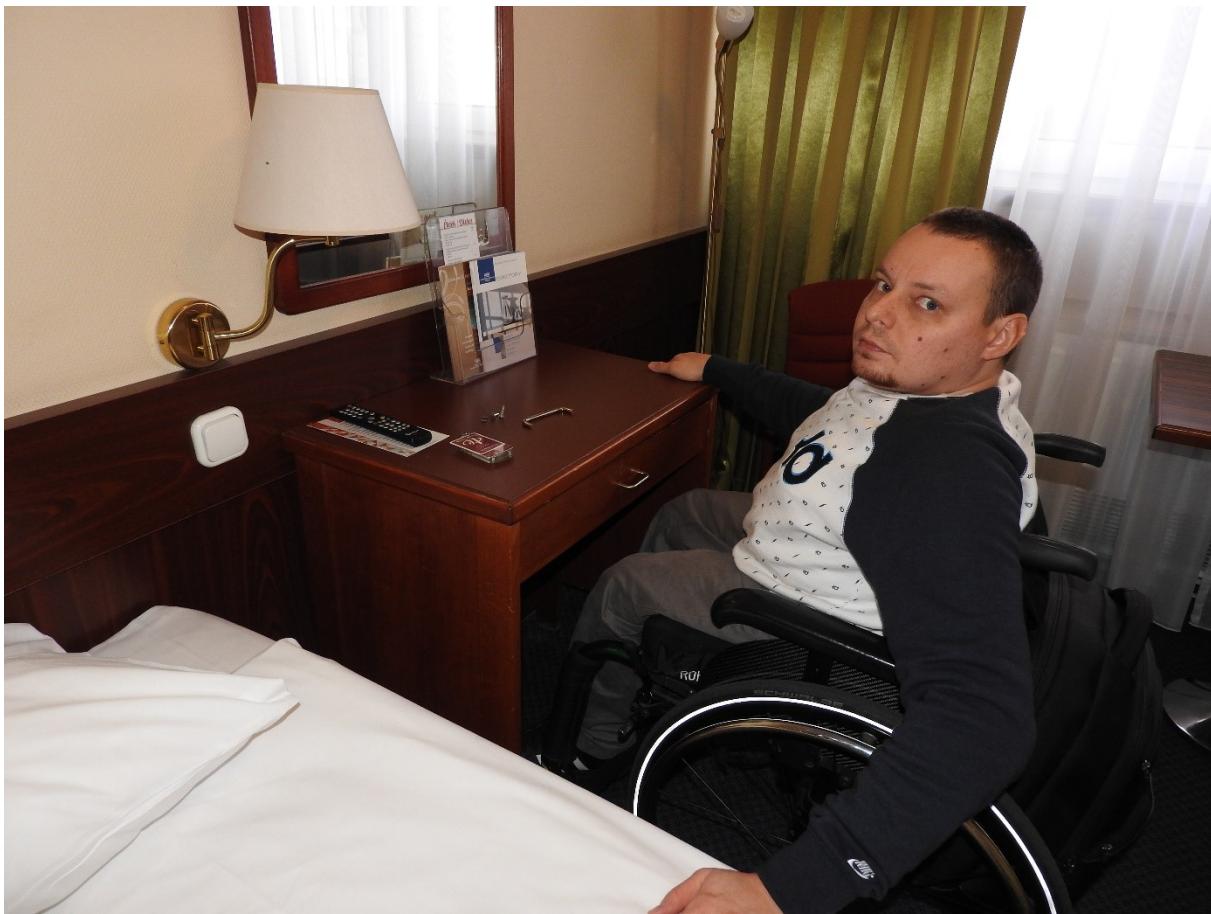
Fig 4 – Accessibility and universal design survey of Hotel Flamenco. Examination of the suitability of the furniture and the ability to maneuver in the room by experts by experience. 2018. Source: ETIKK

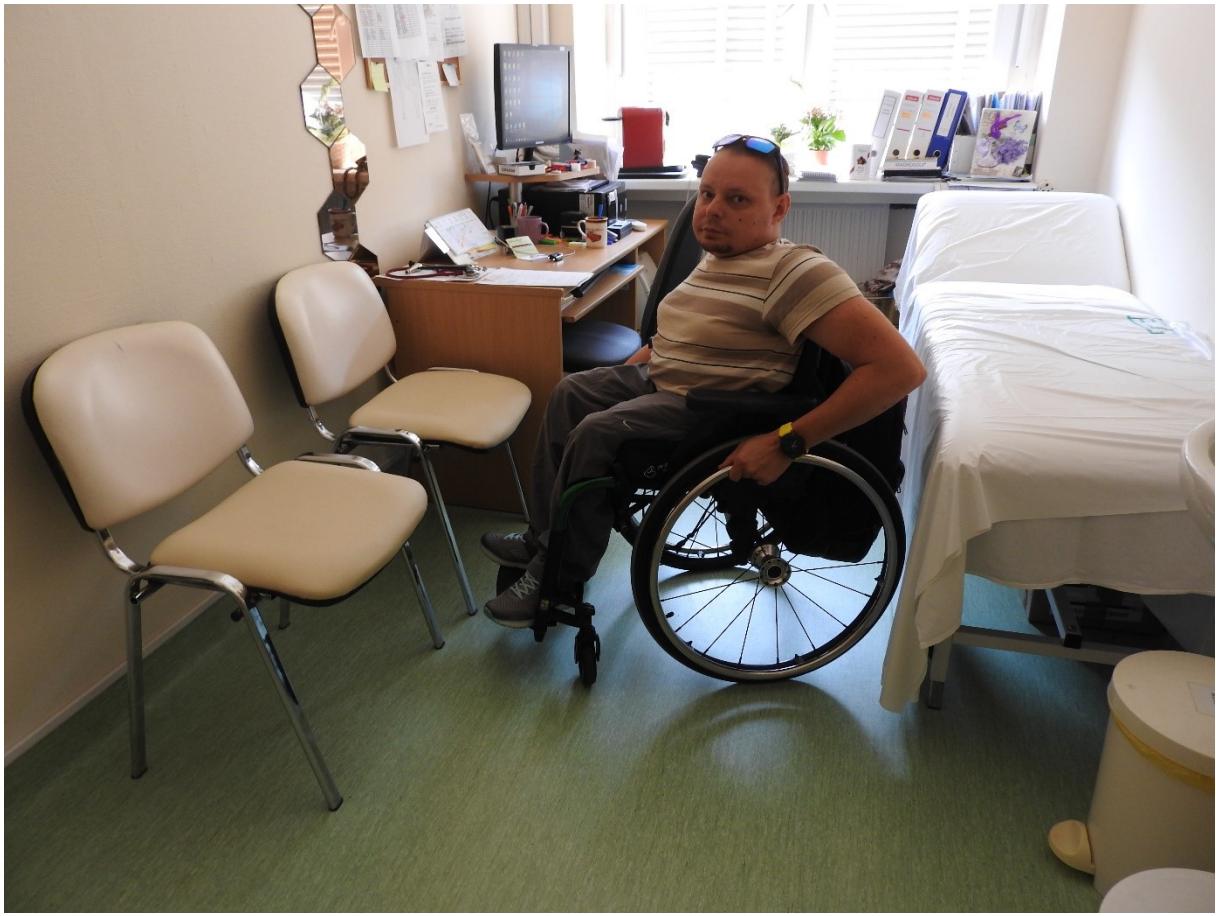
Fig 5 – Accessibility and universal design examination of the medical room. Péterfy Hospital, SM (Sclerosis multiplex) consulting room design examination 2018. Source: ETIKK.

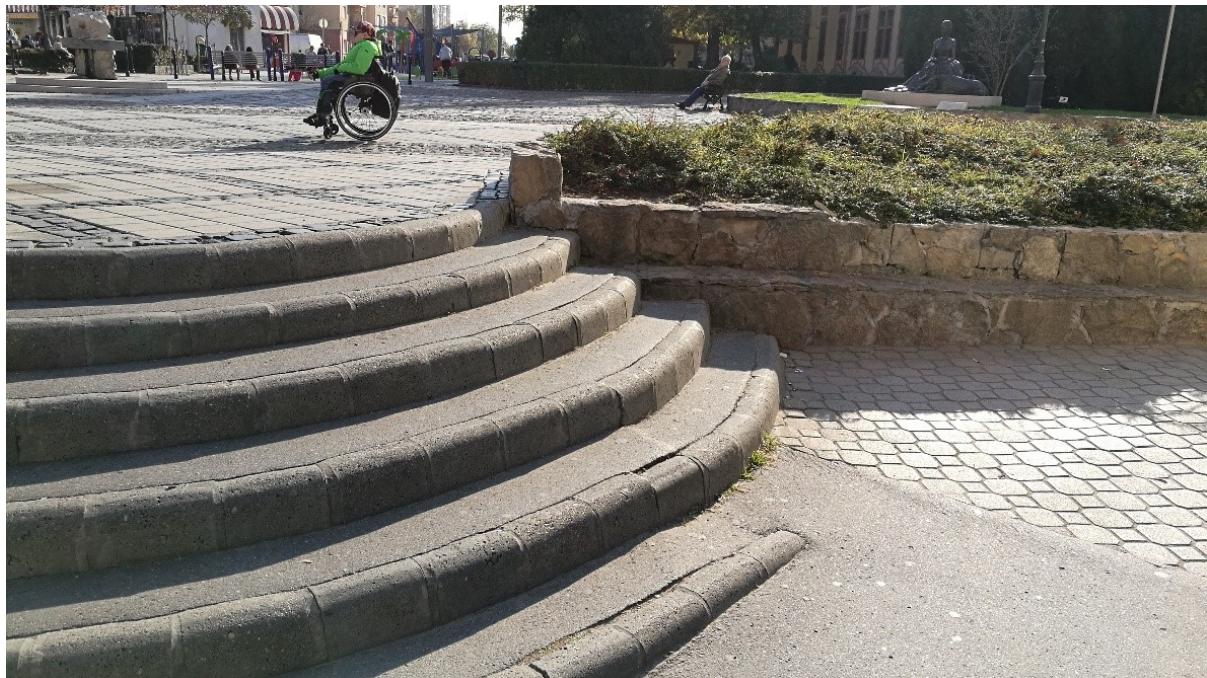
Fig 6. – Budapest, Pesterzsébet center, user test and measurement with expert by experience and rehabilitation engineer. The cubestone pavement is not a good choice from an accessible point of view, because the steps run out and have no railing, and can therefore cause accidents. 2018. Source: ETIKK

For public pavements and geometrical space organisation it is advisable to construct the shortest accessible (better to say: universally designed) route. By paving seamlessness or tight fitting is important, the possibly homogeneous pavements with flat surface help those, who use aid (wheelchair, rollator, stick, artificial leg, pram, roller, skateboard etc.) at traveling. In case of historical districts, there are technical solutions, that by reconstructing only a part of the pavement, makes continuous progress possible for everyone.

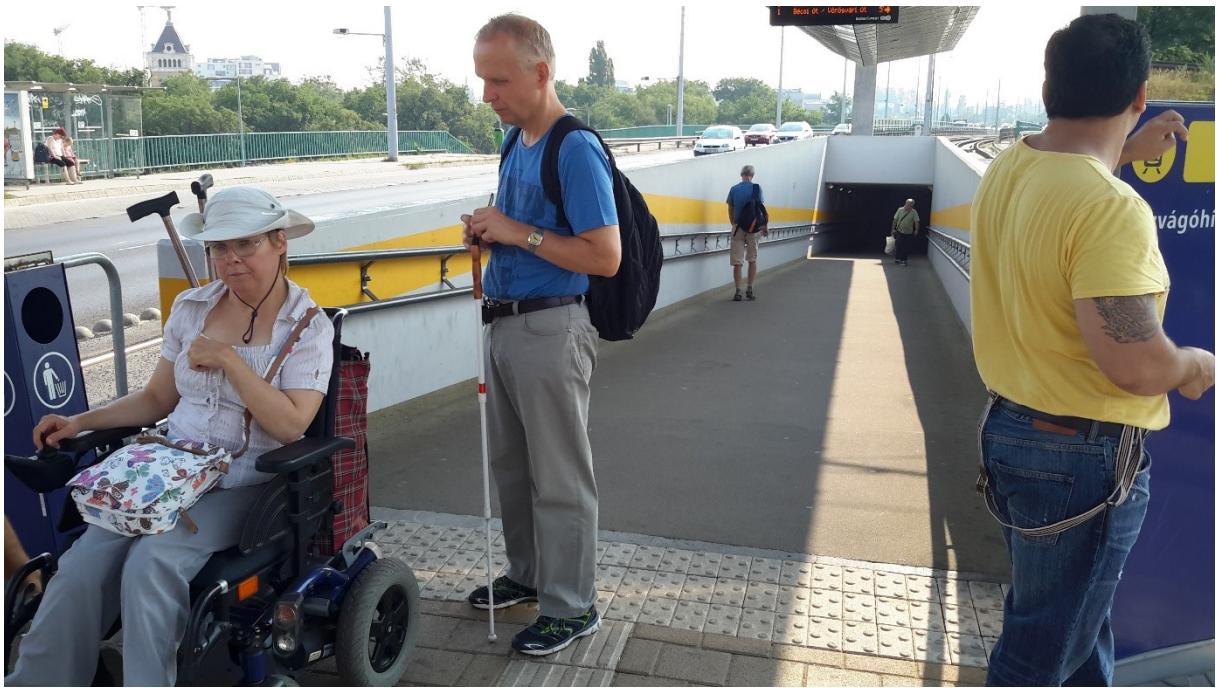
Fig 7. Közvágóhíd ramp examination with experts by experience. The long ramp section without resting places can exhaust the manual wheelchair users easily. The tactile signals and handrails in two rows on both sides are appropriate. 2015. Source: ETIKK

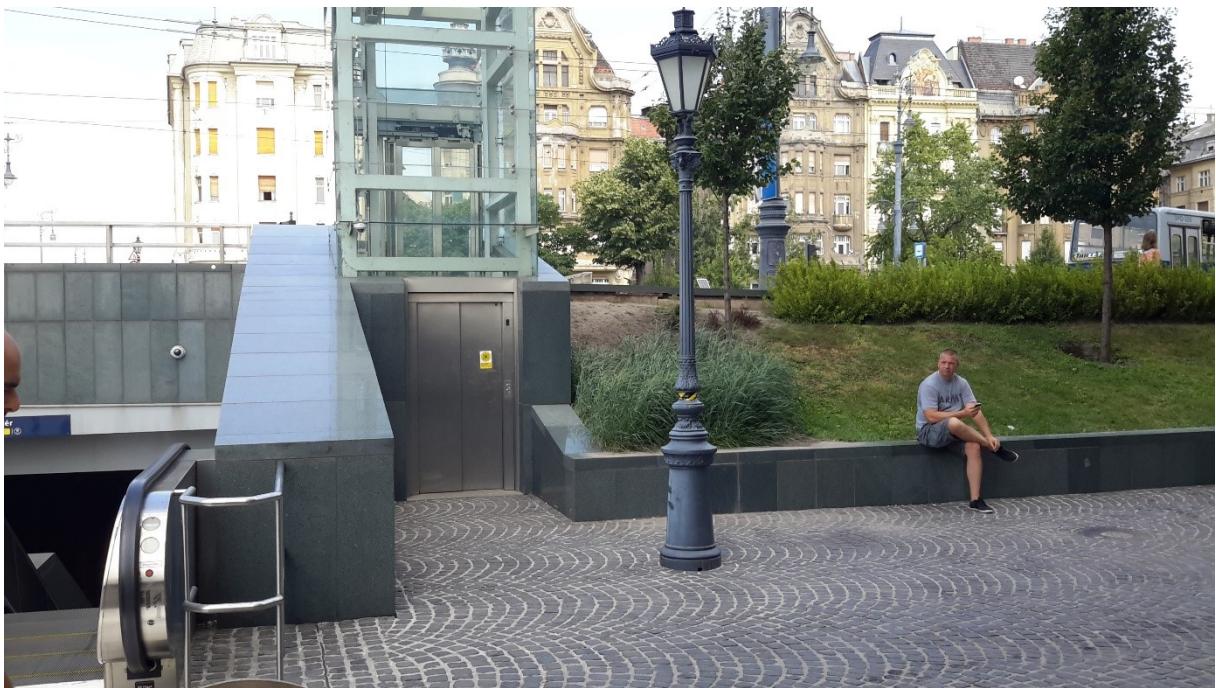
Fig 8. – Tram and metro station hub. Stairs, lift and comfort escalator are constructed. Fővám square 2015, Source: ETIKK

In case of bigger transport hubs with more transport modalities (e.g. bus, metro, tram, train), where one can transfer, we recommend multilevel, complex accessible reconstruction. Barrier free lifts, ramps and comfort escalators are all needed for accessible transport at those facilities, that have a high traffic.
